Minerals Inspection Report

Report Date: 04/21/2014

Mine Name: La Sal Mine	Permit Number: M/037/0026	Mine Status: Active
Operator Name: Energy Fuels Resources (USA)	Inspection Date: 04/15/2014	Permit Fees: Paid
Inspector(s): M. Bradley	Inspection Time: 10:00a	Bond Amount: \$348,686
Attendee(s): See below	Weather: Pt. ClDY, cool	Bond Escalation: 09/21/2015
Inspection Purpose: Routine inspection		Prior Inspection: 06/13/2013

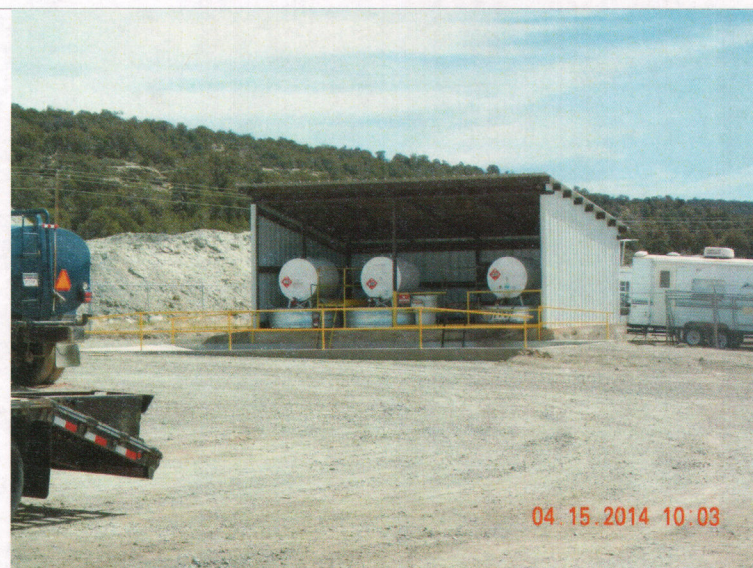
Fuel storage containment structure

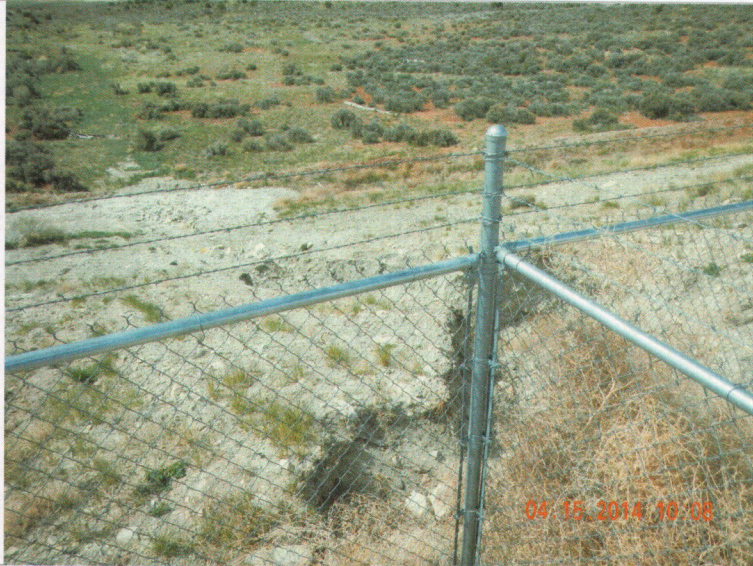
Attendees: Becky Doolittle, BLM; Joe Manning, BLM; Andrea Reither, Stephen Downs, EFR; EFR; Race Fisher, EFR; Todd Eldredge, EFR.
No significant changes since last inspection. Some erosion off south side of parking lot (see photo). Portal still sealed. No visible evidence of eminent threats to public health and safety.

2. <i>Public Safety (shafts, adits, trash, signs, highwalls)</i> Portal remains sealed	<input checked="" type="checkbox"/>	<input type="checkbox"/>
3. <i>Protection of Drainages/Erosion Control</i> Some erosion off of parking lot had formed a gully on south site. Parking area regraded, but outslope needs some attention (see photo).	<input checked="" type="checkbox"/>	<input type="checkbox"/>

Erosion on south flank of parking lot

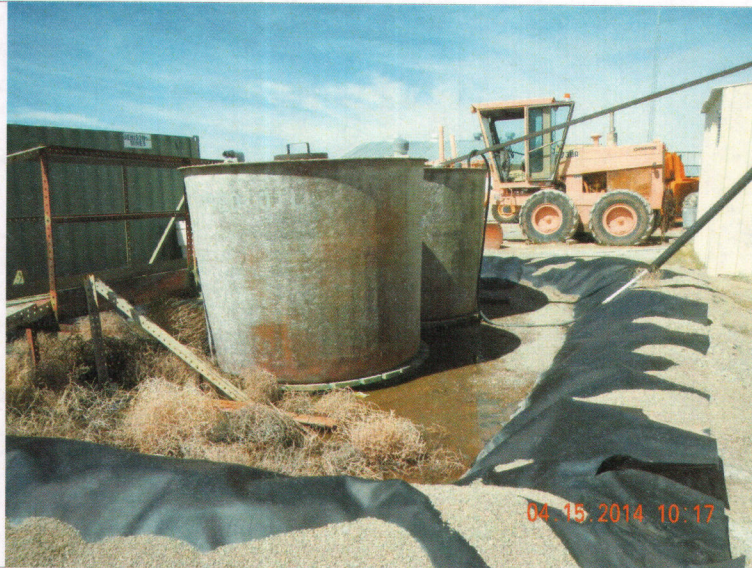
Used oil storage tanks (empty) inside containment berm

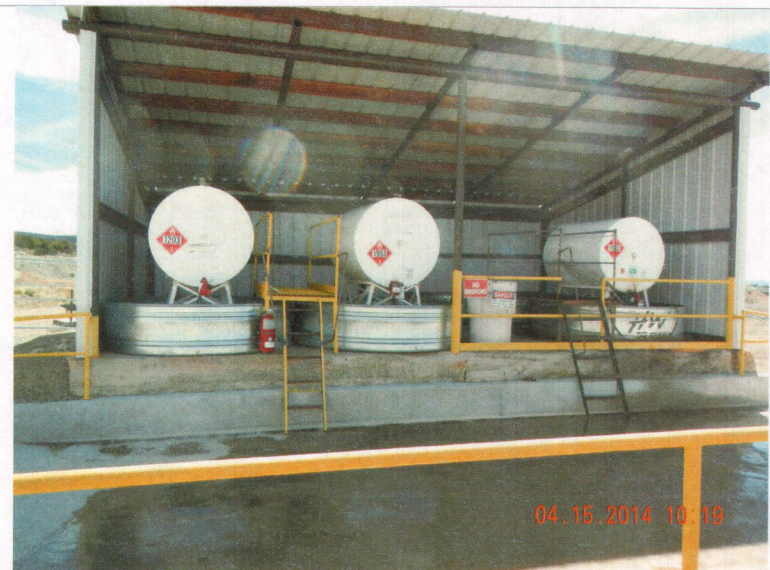
4. <i>Deleterious Material</i> Fuel and lubricant tanks have been emptied in anticipation of period of temporary suspension; fuel containment system in good repair. some of the exposed secondary containments have precipitation water in them. Not an issue as long as no fuels or oils are stored in the tanks.	<input checked="" type="checkbox"/>	<input type="checkbox"/>

View of precipitation water in fuel storage containment

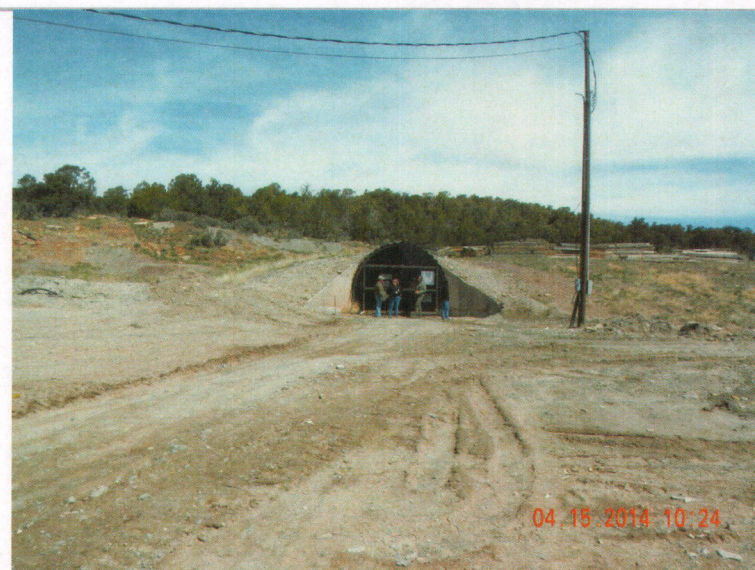
Portal

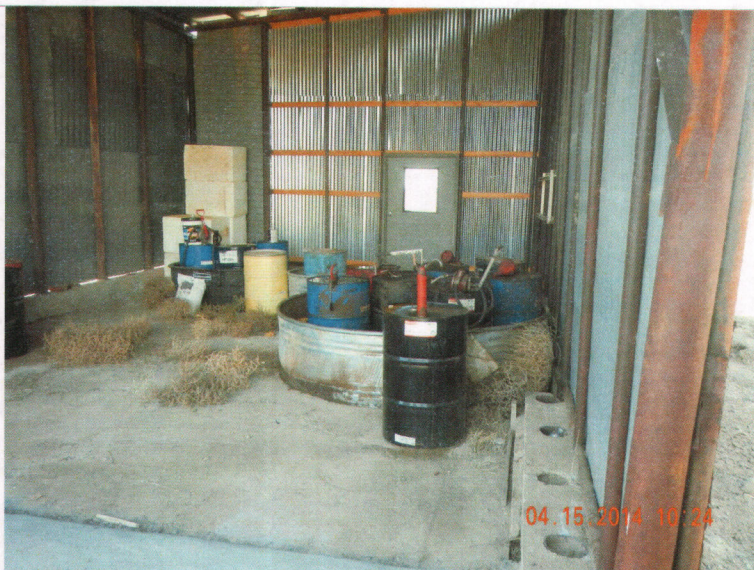
Fuel and lubricant containment shed near portal

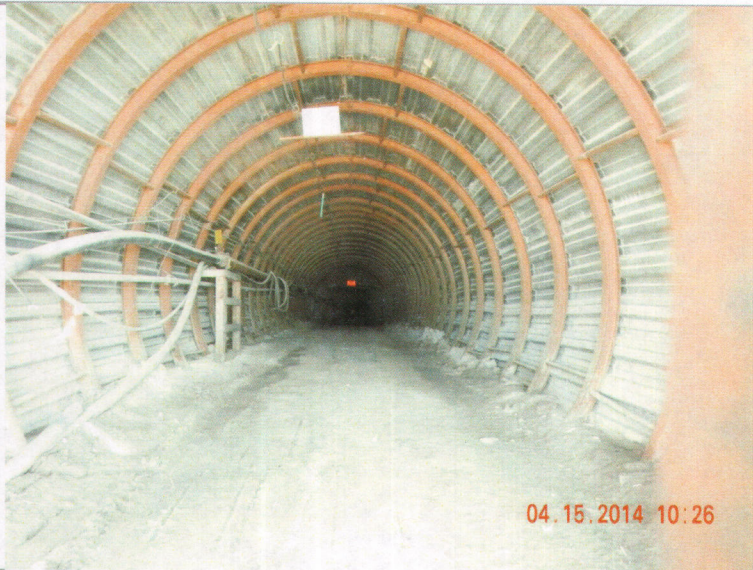
View into portal

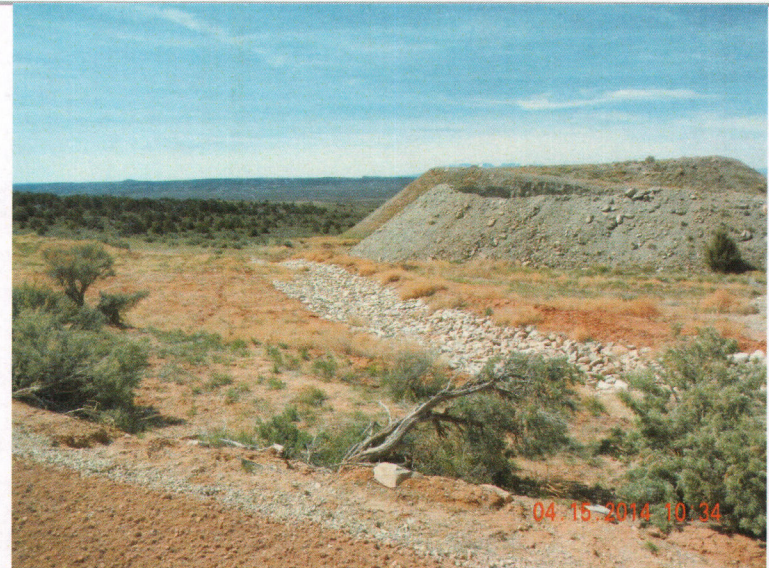
View of riprapped drainage at east boundary of site
